STEAM LOCOMOTIVE SERVICES, INC.

REPORT ON DELAWARE & HUDSON GRAVITY RAILROAD COMBINATION FREIGHT & PASSENGER CAR

This report, prepared November 9, 2001 covers my inspection of the former Delaware & Hudson Gravity Railroad combination freight and passenger car owned by the Carbondale Historical Society and Museum, Inc. whose offices are located at One North Main Street, Carbondale, Pennsylvania 18407. The inspection was conducted with the assistance of the organization's Executive Director, Mr. Robert Powell at the Homestead Golf Course where the car is stored on September 10 & 11, 2001. Photographs taken at this time are enclosed and identified in attachment - A.

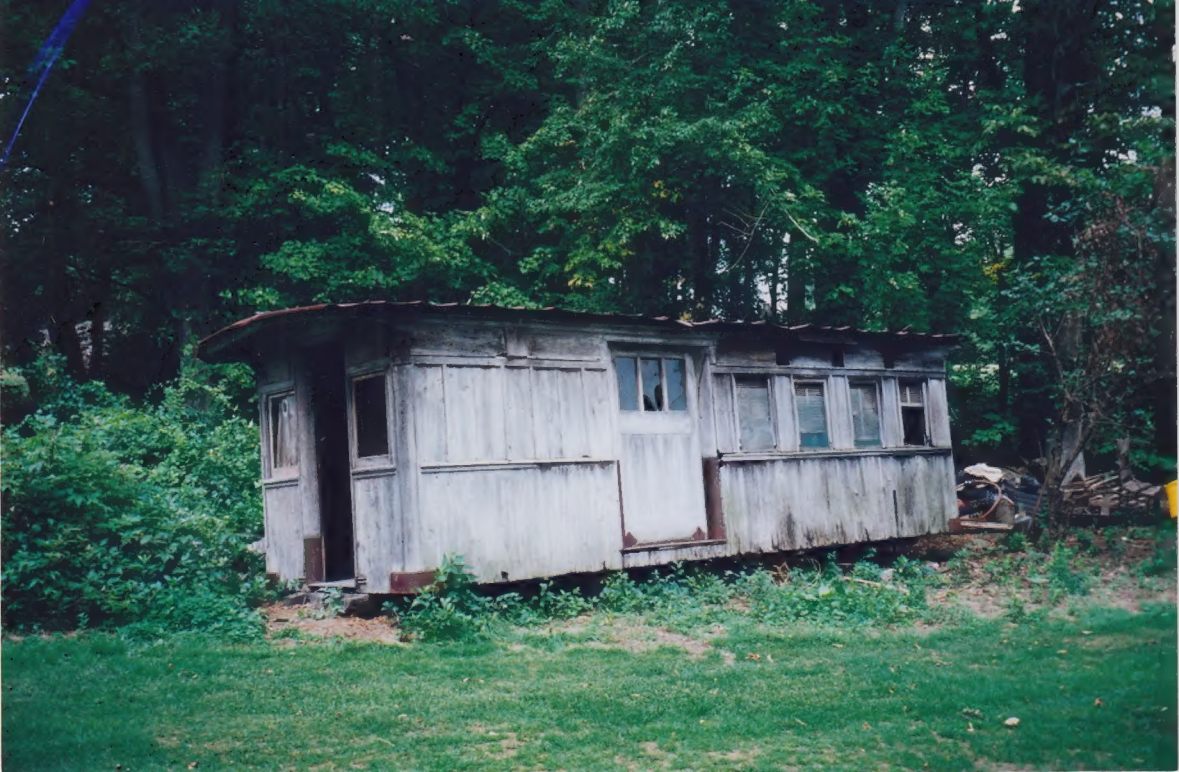
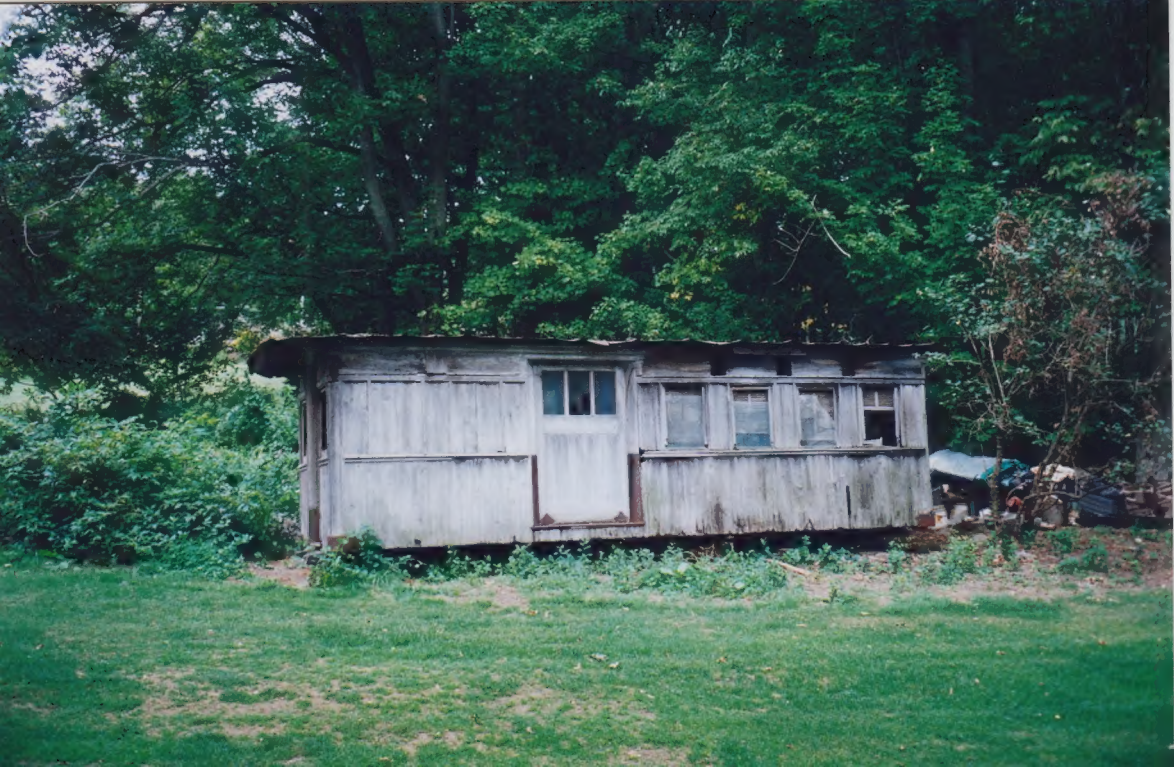
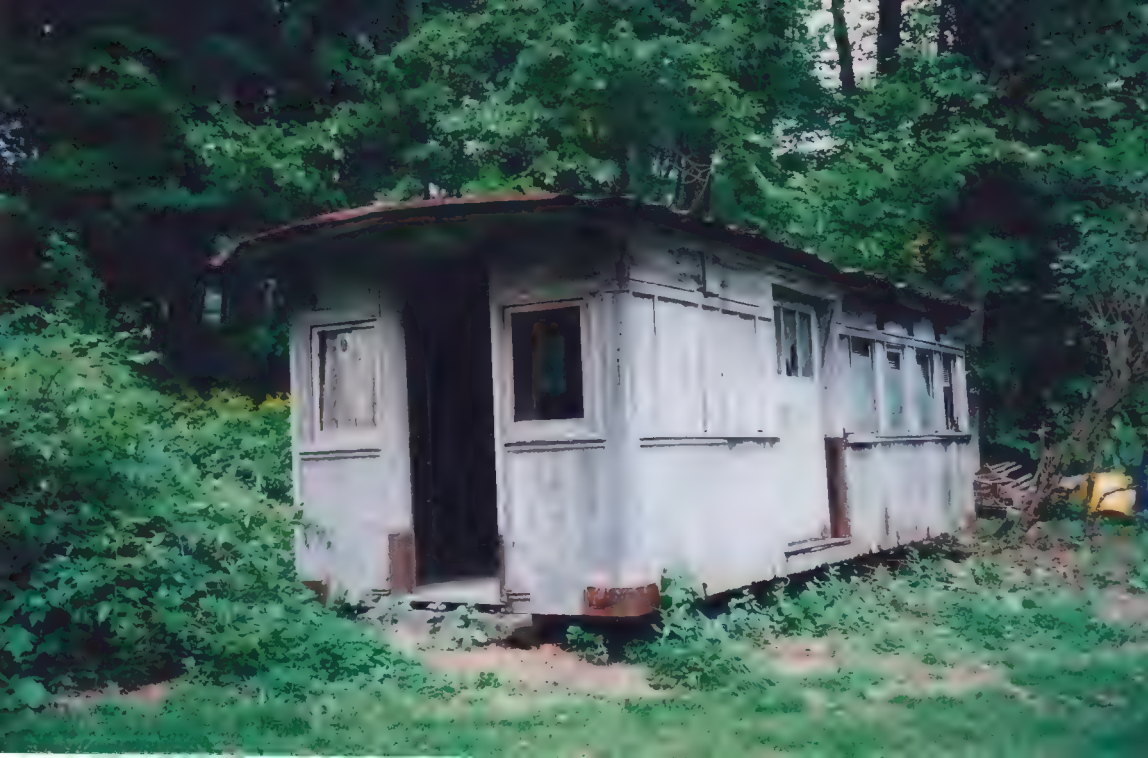
Number	Description
1-3	Exterior, left side
4-5	Exterior, right side
6	Baggage end
7-9	Baggage door and details, left side
10	Belt rail detail, right side
11-12	Window and sill details, left side
13-14	Outer vent cover and outer vent opening, left side
15-19	End hood details, both ends, both sides
20	Mounting bracket for unknown object, under passenger end hood
21	Passenger end detail
22	Passenger end door
23-24	Passenger end window details
25-28	Car frame details as seen from trench dug under car
29-31	Car interior views
32-34	Baggage end interior details
35-37	Car interior details of window and blinds
38	Interior ceiling
39-40	Interior baggage door and track details
41	Detail of interior roof bows with ends rotted and ventilator
42	Detail of ventilator
43	Detail of floor showing damaged section
44	Detail of floor showing where baggage door guards were mounted
45	Detail of interior where paint was sanded to reveal layers

Left side: Replace all exterior wood including tack moldings, letter board cap strip, letter board, battens and boards, window sills, belt rail, siding and four sash. Note that once this wood has been carefully removed for use in making replacements it is likely that interior framing will be found to be in need of replacement or repair as well. Also note that some sections of siding removed may be useful for patching other areas.
